### **Austin Healey 3000 BJ6**

It all started innocently enough. J.M. had wanted to rebuild the driveline on his 1964 Austin Healey 3000 B18 for several years. Previously the engine had had problems with smoking exhaust, with pushing oil out from the crankcase breather, and with low oil pressure. I had read Norman Knock's Tech Tips about worn rocker shaft bushings causing 2 of 3 of these problems. After replacing the rocker shaft and re-bushing the rocker arms, the blow-by and oil pressure both improved staving off the rebuild. More recently, after hearing a loud clanking noise from the engine, J.M. decided the "winter" of '99 was finally the time to do the rebuild.

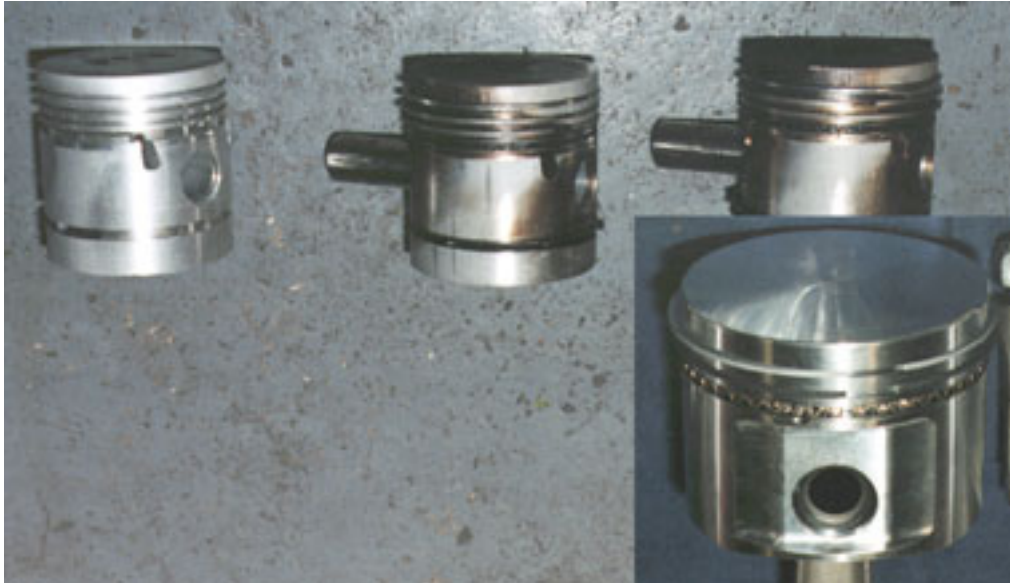
*Piston in the lower right is the modern JE Piston. The others are original.*

- Custom-made three ring (as opposed to the original 4 ring heavy pistons) lightweight forged high silicon content forged aluminum pistons from IE.
- We had the steel flywheel lightened.
